Degradation of AISI 314 Steel at Elevated Temperatures

This work studies the behavior of AISI 314 steel subjected to an atmosphere rich in hydrocarbons at high temperatures, verifying the reasons that led to the collapse of stainless steel. The alloy was analyzed by optical emission spectrometry to determine the original composition and after its use in service. The research conditions took place at a temperature of 1200 °C. The Vickers microhardness test demonstrated a decrease in microhardness from the surface towards the core. With the use of Optical Microscopy (OM), Scanning Electron Microscopy (SEM) and Energy Dispersive Spectroscopy (EDS), it was possible to observe the presence of Cr segregations, along the grain boundaries, especially with the presence of Cr carbides. In the immersion corrosion test, the effect of precipitates on corrosion resistance was evaluated. The results obtained evidenced the presence of sensitization, silicon segregation and chemical unbalance of the steel. The formation of precipitates on the grain boundaries, reducing the corrosion resistance of the samples studied, in addition to decreasing the toughness of the material, causing catastrophic fai

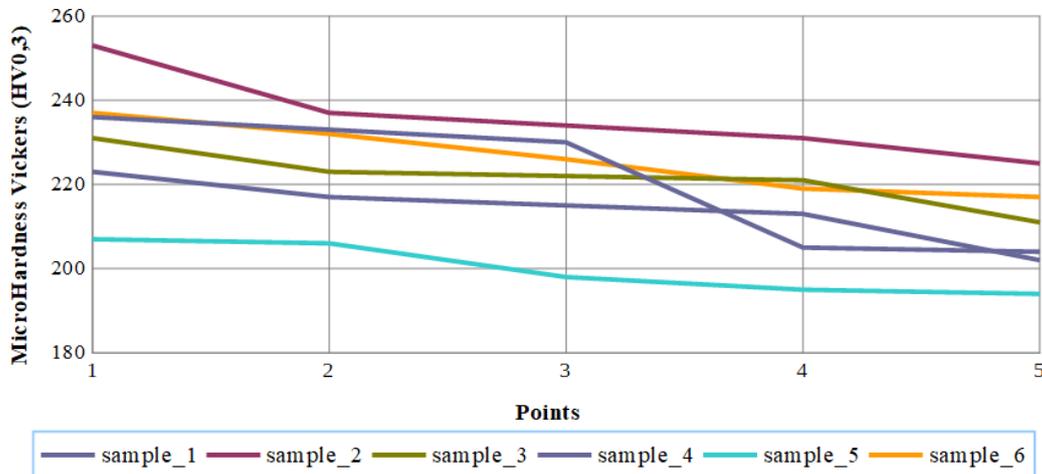
Figure 1 - Curve with the results of the Vickers microhardness test for all Samples.

Close to the surface, the presence of higher microhardness values than the core was verified, indicating carbon enrichment. Through the hardness tests, it was possible to verify that the hardness in all the samples had a decline as it progresses in indentations from 1 to 5 (surface - center), indicating carbon diffusion from the surface, weakening the Sample.

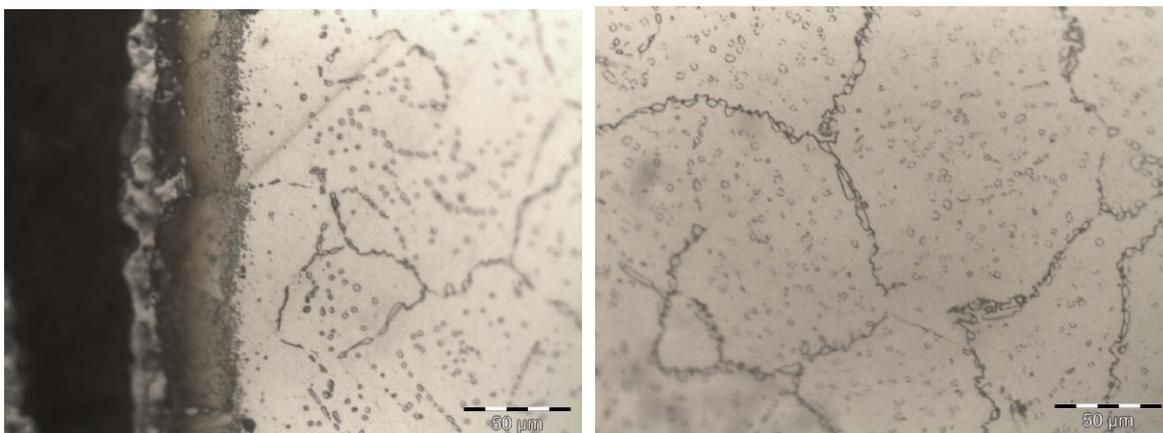
In Figure 2, it is possible to identify the chromium carbides, characteristic of sensitized stainless steel, next to the precipitated grain contours.

Figure 2 - Presence of precipitates near the grain boundaries.

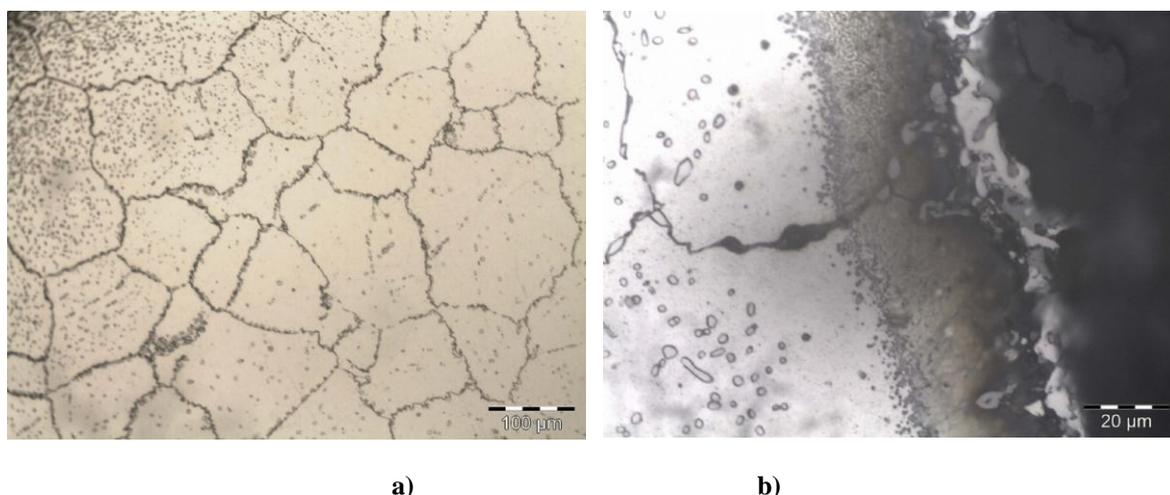
Figure 3 - a) Abnormal grain growth due to the high temperature applied. b) Anisotropy is typical of the degradation of stainless steel.

Figure 3 a) represents an abnormal growth of the grain due to the high temperature to which it subjected to the piece. In Figure 3 b), the precipitation of carbides of type $M_{23}C_6$ [21] is noticed, causing the depletion of chromium in the regions adjacent to the grain boundaries.

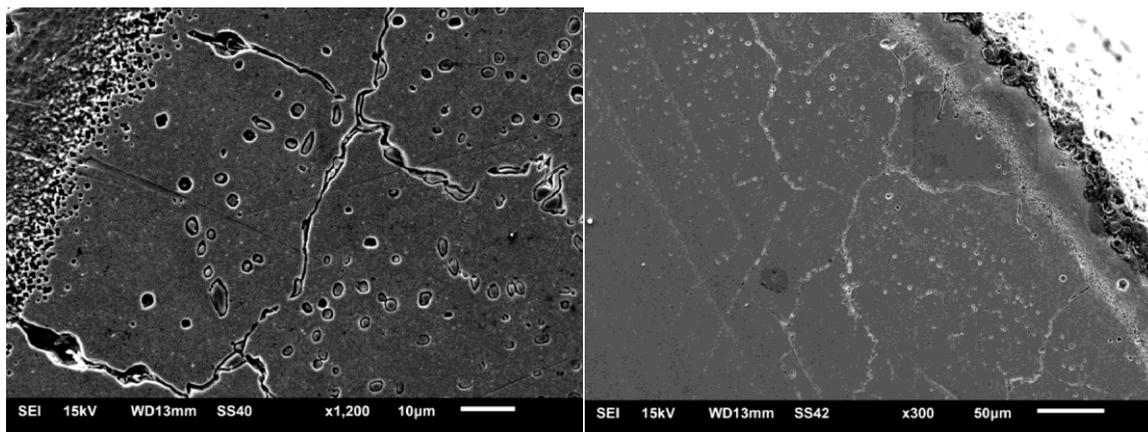
Figures 4 show the images captured by SEM, and Figure 5 show the results obtained by EDS. It is verified in all the precipitated samples degrading the analyzed surfaces and the presence of corrosion pits. This condition is associated with the partial rupture of the chromium oxide layer and the reduction of the Cr content necessary for repassivation [3]. In Figure 4, the presence of precipitates observed, as well as the formation of corrosion pits.

Figure 4 - Precipitated next to the grain contours.

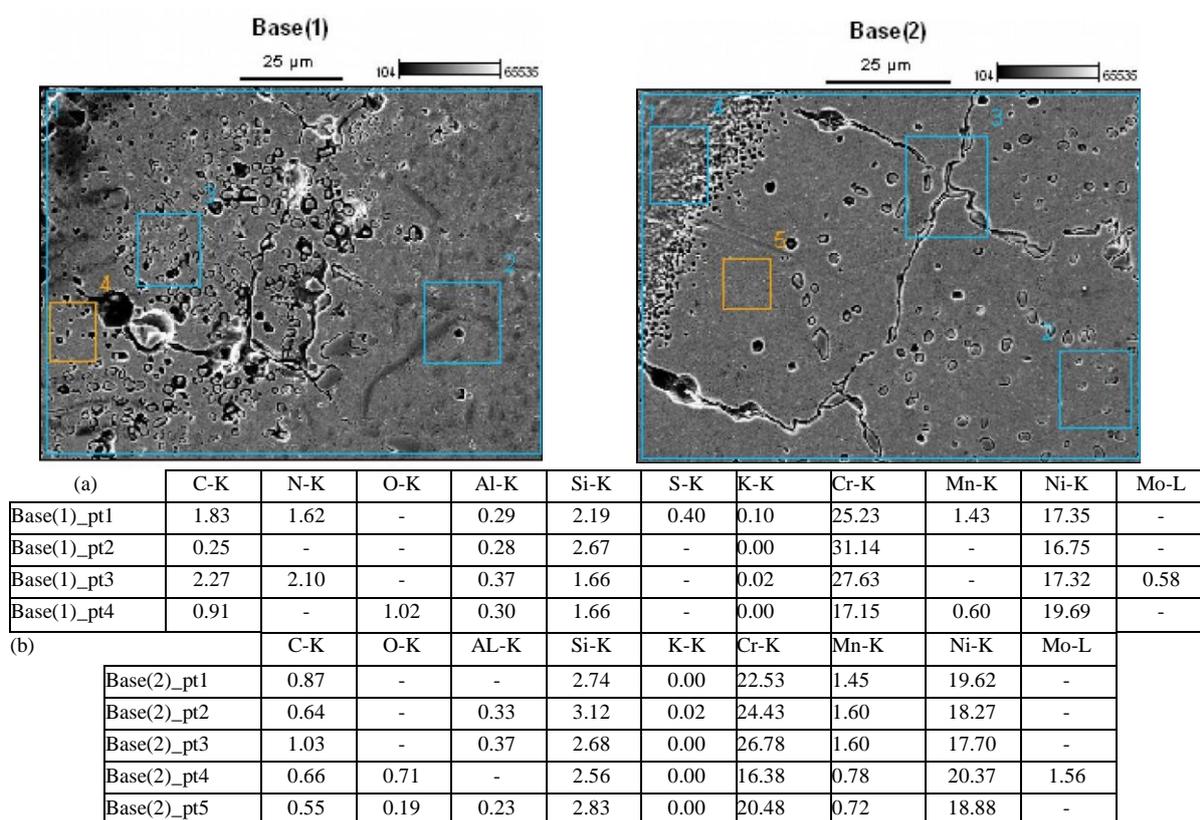
In Figure 5, we see a decrease (segregation) of both chromium and silicon from the center of the piece to the surface. Interestingly, a value of less than 11% in Chromium was not found in the analyzes by DES, although it is evident the presence of the formation of precipitates, as well as the percentage of Si that remained between 1 to 3% in all analyzed portions. However, as widely reported in the literature, the EDS assay is qualitative, not quantitative.

Figure 5 – Precipitated along the grain boundaries and surface degradation.

In Figure 5 b) a reduced amount of Chromium is also observed in Rectangle 4, closer to the surface of the piece compared to Rectangle 3 ($M_{23}C_6$), indicating a zone depleted in Chromium around carbides rich in this element, typical of sensitization, forming a micropile, where the chromium-rich region will be cathode and the poor anode, where it will corrode. Also, in Rectangle 3, we can see the high percentage of carbon compared to the other locations analyzed.

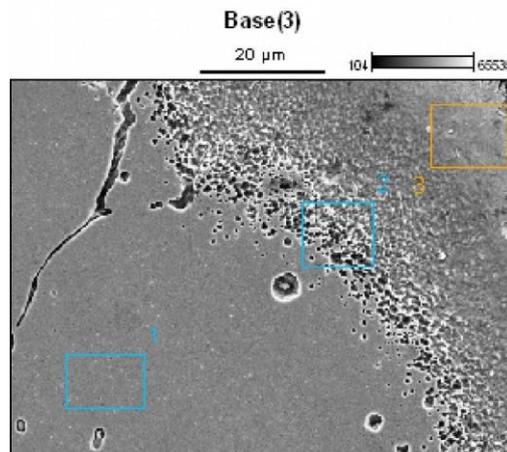
Figure 6 - Precipitated next to the grain contours and superficial degradation.

In Figure 6, we can see the segregation of chromium and silicon towards the surface. For the immersion corrosion test, the sample was removed from bakelite, and then immersed in the NaCl solution, at room temperature, and showed signs of corrosion. The presence of corrosion in the sample was after 72 hours. This behavior indicates severe degradation of the passivated layer and reduction of Cr for repassivation. There is also a significant increase in nitrogen, which causes the austenitizing effect. The silicon reduced due to the atmosphere and the working temperature to which the sample was exposed.
