Analysis and Failure Improvement of Shaft of Gear Motor in CRM Shop

ABSTRACT : The overall subject of this paper is the frequent failure analysis of output shaft of gear motor used for cold rolling mill to drive the Pay-off Four-HI (Horizontally inserted). One end of that shaft is connected to the claw coupling to the drive of the Pay-off four-HI .By considering the drive system forces and torque acting on the output shaft are determine using which the stresses occurring at the failure section are calculated . Stresses analysis is also carried out with analytical method and comparing these results with the software results that is done using the ANSYS software after getting all the different parameter redesign of shaft is done and again analyzing the shaft using ANSYS and hope that shaft may torsional Rigid.

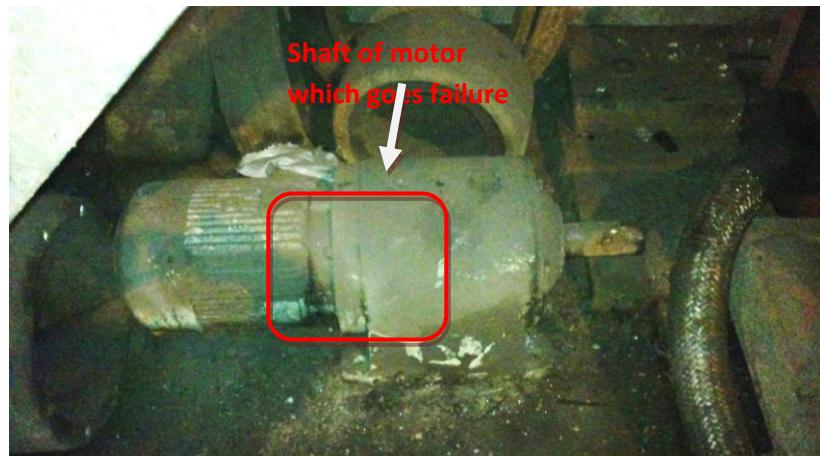
There are three types of load act on the output shaft of gear motor Torsional load acted by the roll of Pay-OFF 4HI on the shaft, while in action, the torque is up to 1281N-m Direct bending loading acting act by the load of roll i.e. 500kg by each roll and pressure acted by the two hydraulic cylinders, 80kg each. Additional torque acted by the sheet metal while sheet has been drawn from Pay-OFF to the rolls of Cold rolling mill, the maximum speed of motor of Cold rolling mill is 1000 rpm, that why, additional torque is too large, and up to 30000 N-m.

Fig. Shaft of gear motor and broken casing

1. By Changing the material of good shear strength , the shaft may sustain in the maximum loading condition
2. Re-design the shaft with modified diameter and use in Scraper motor.
3. Select the Proper model of motor having the least diameter of shaft is more than 75mm.
4. Maintain the speed of both Gear motor and motor of cold rolling mill by installing new gear box for cold rolling mill up to the
5. disengagement of Gear motor Shaft from pinch roll of Pay-OFF.
