Analysis and Failure Improvement of Shaft of Gear Motor in CRM Shop

ABSTRACT : The overall subject of this paper is the frequent failure analysis of output shaft of gear motor used for cold rolling mill to drive the Pay-off Four-HI (Horizontally inserted). One end of that shaft is connected to the claw coupling to the drive of the Pay-off four-HI .By considering the drive system forces and torque acting on the output shaft are determine using which the stresses occurring at the failure section are calculated . Stresses analysis is also carried out with analytical method and comparing these results with the software results that is done using the ANSYS software after getting all the different parameter redesign of shaft is done and again analyzing the shaft using ANSYS and hope that shaft may torsional Rigid.

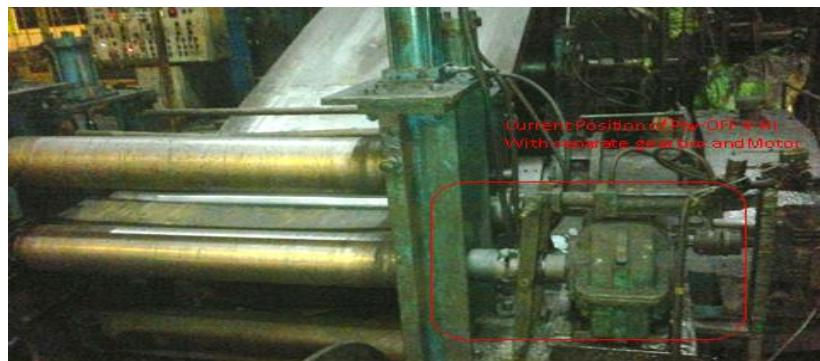
Fig. Pay-OFF4HI with separate Gear box and Motor

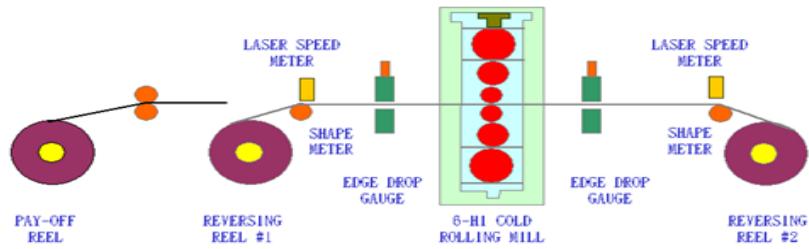
Fig. Pay OFF system with Cold rolling Mill

B) While the pay-off en-gauge with main rolling mill, as pay-off is used for providing the coil to the main rolling mill system , and at instance that pay-off get dis-en-gauged ,while during the dis-en-gauging the pay - off whole torque of mail rolling mill comes on the pay of and shaft of gear motor ,that drives the pay-off system goes failure.
